Re: Woolworth Investigation
Commons Shopping Center
St. Albans, VT

This letter summarizes the results of a subsurface investigation performed by Heindel & Noyes (H&N) on June 16 - 17, 1999 at the site of the former Woolworth's garage at the Highgate Commons Mall in St. Albans (refer to Appendix 1, page 1). Accordingly, the letter documents field activities, presents laboratory analytical results, and gives conclusions and recommendations as to the future action at the site.

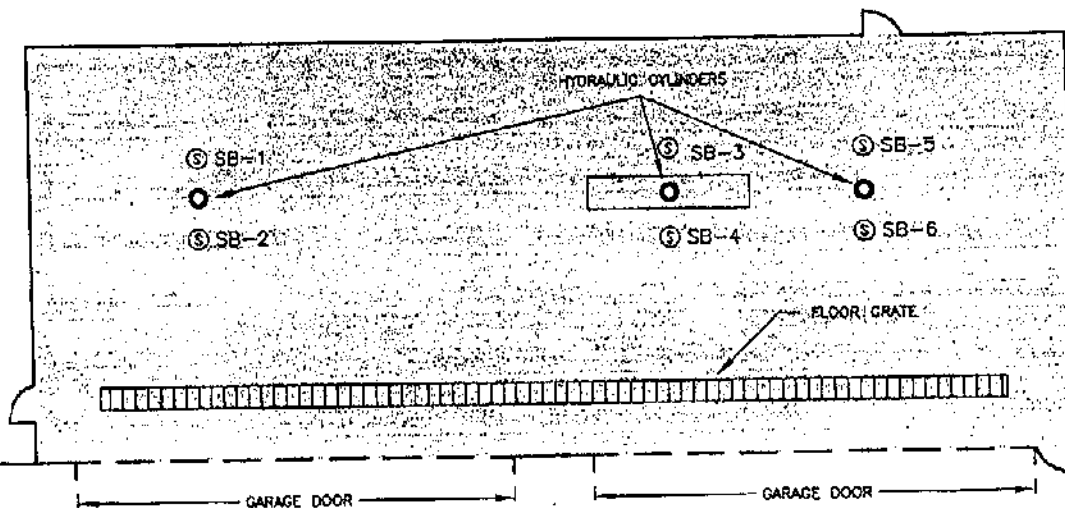
⑤ SB-4 SOIL BORING

Soil samples were collected at approximate 2-foot intervals to properly classify the soil stratigraphy underneath the site. Observations were made as to the soil type, texture, moisture content, visual and olfactory signs of contamination, and were then screened for volatile components using a photo-ionization detector (PID). Refer to the attached boring logs for the full description of each sample that was collected. After screening, three of the samples, one from each hydraulic cylinder, were collected in 40-ml vials and preserved on ice for future laboratory analysis. The depth intervals of these three samples, SB-2, SB-4 and SB-6, are also shown in Table 1.
